DAYSAILER TECHNICAL NOTE D. J. Bents

[From The Day Sailer, #100, Spring 1986] DS II Center-board Trunk Leaks

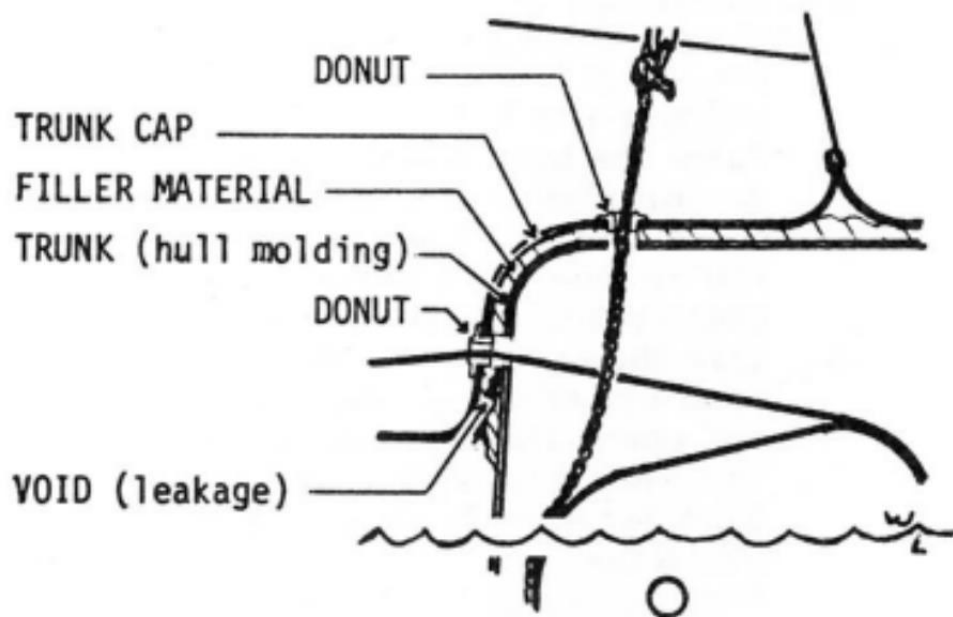
The filler in this sandwich is a chopped fiber(glass) putty, used to cement the joints between the hull and cockpit moldings. During assembly, most of it gets squeezed out to fill voids when the moldings are pressed together. The pendant through-holes are drilled after this assembly step. If the voids were not completely filled in where the hole is drilled, or if the filler material has cracked and broken away from inside the hole, then there is a direct path for water to get in. The pendant holes themselves are pretty large — 3/4" — fortunately, they are located above the waterline. Nevertheless, water splashing up inside the confines of the centerboard trunk is under considerable surge pressure; it is literally pumped in by wave action through any opening that appears.

The forward (raising) pendant hole is the most likely place for this to occur since it is the lowest. Worse yet, the steel cable tends to cut into the surrounding material like a bandsaw, each time the board is raised. Over time, the hole will grow into an elongated slot; this only lets more water in. The problem can be fixed temporarily by jamming some filler putty inside the hole. Or, you can fix the problem for good simply by tapping out the holes and threading brass pipe nipples into them!

How water gets in

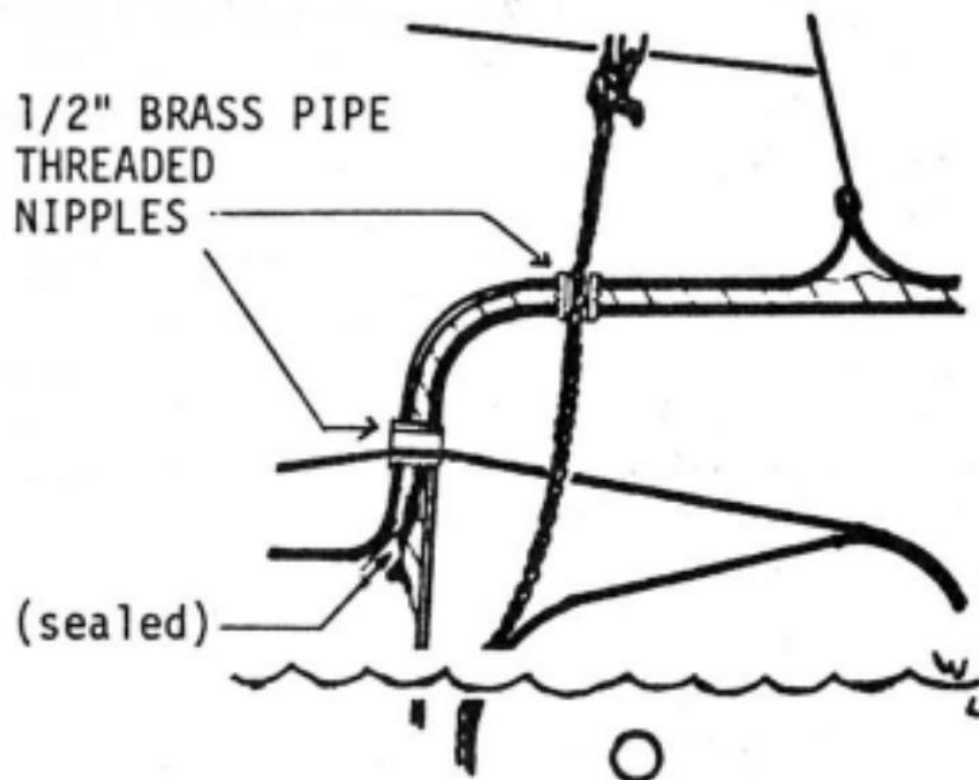
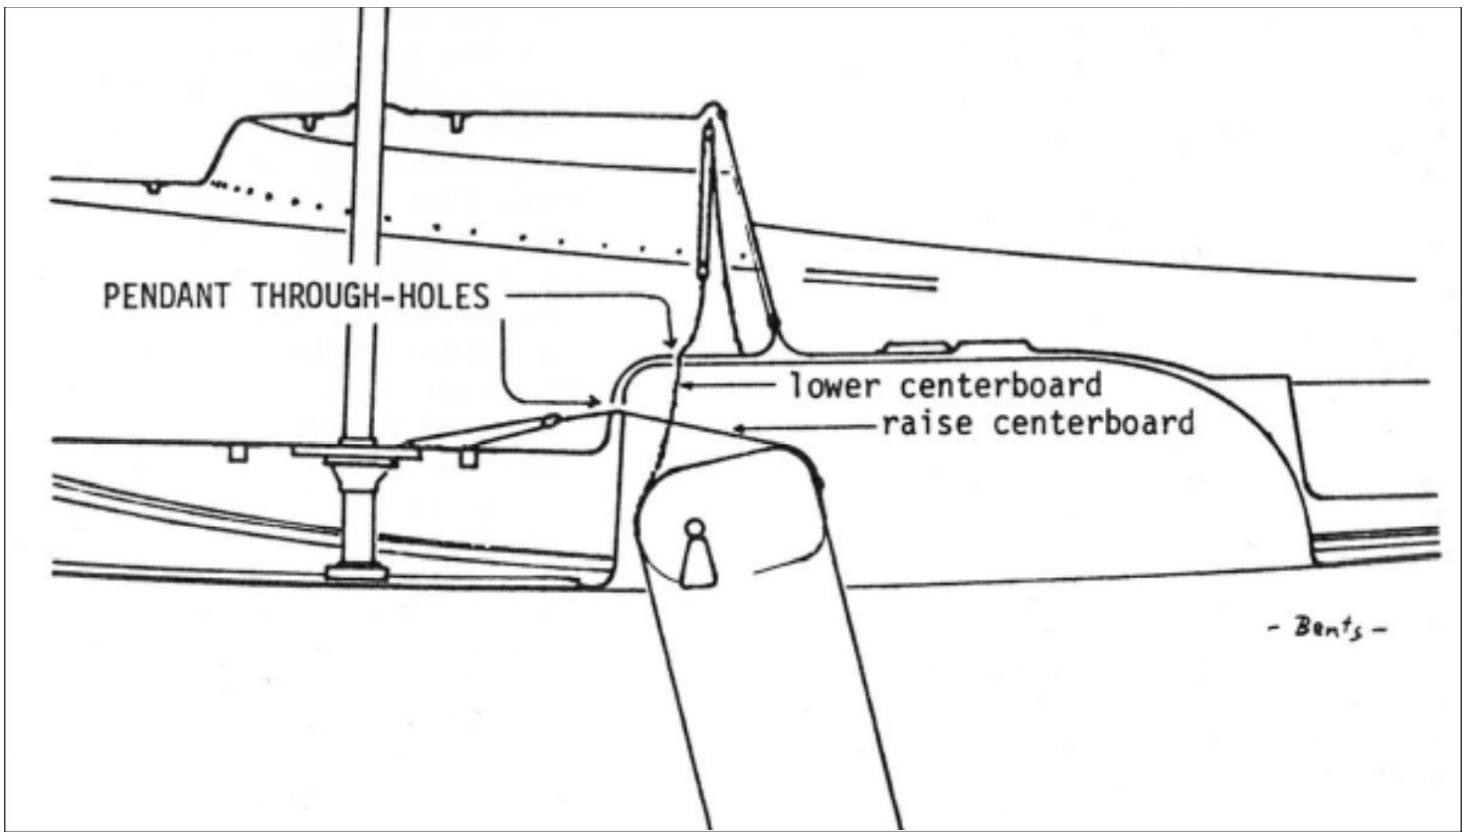
How to fix it

The factory-drilled pendant holes are only slightly larger than the starting diameter of a half-inch NPT pipe tap. The trick is to tap each hole only deep enough to thread the nipple all the way through the centerboard trunk, yet protrude no more than 1/8" or so into the interior cavity (to

allow clearance for the board and pendants). The fiberglass taps easily and will hold a threaded joint that is strong and tight. The pipe nipple will reinforce the hole, stop the leakage and allow the cable to slide freely without sawing into anything. A swaged loop will pass through the diameter that remains without difficulty.

6. Tap out each hole with the pipe tap. Tap it out in several passes; taking care each time to stop and thread the nipple in to see how much further it needs to go. If the hole is very much off-center in the trunk, you may want to grind or file down the nipple end to match the trunk cavity's interior contour more closely. Brass is a very easy metal to work with, so don't let filing to match a contour scare you. You will have to go back underneath the boat many times to see where the nipple is emerging. Strong sunshine or a powerful drop light helps.

7. When you are satisfied with the way the nipples fit when they are threaded in tight, go back and remove them, clean them, and re-install them with epoxy.

9. Wait for a day, then go back and cut the remaining pipe off next to the trunk cap. Use the file to face it off smooth and flush.
10. Re-install, re-assemble, re-connect. You will be surprised at how dry the bilges remain, even in rough water.
